# Improved Requirements for Stress-Grading Systems at Hydro-Québec

Rémi Tremblay <sup>(1)</sup>, Claude Hudon <sup>(2)</sup>

<sup>(1)</sup> Generation Engineering, Hydro-Québec, Montréal, Québec, Canada

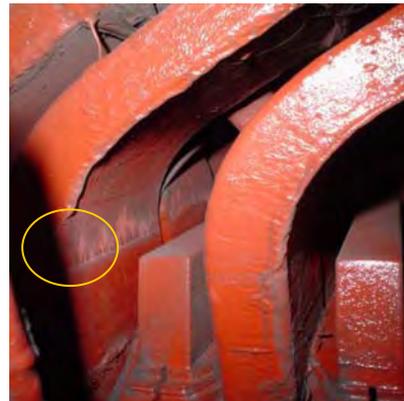
In recent years, inspections have revealed traces of white powder at the junction of the semiconductive and grading coatings of a number of Hydro-Québec stator windings. The white powder results from surface discharges attacking and decomposing the insulating material and by air ionizing around the bar. Such defects were even seen on stator windings with only four years of service (see Figure 1).

Figure 1 – Signs of discharges on a winding after just four years of service

On-site corrective action must be taken to remedy the deterioration before it becomes critical. This entails shutting down generating units, which is clearly undesirable in an increasingly competitive market for electricity sales.

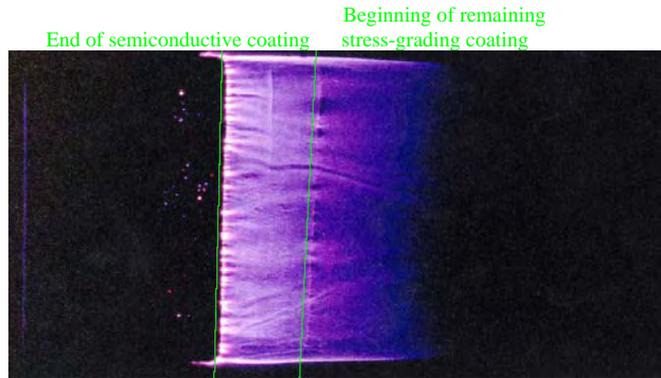
Several bars were subjected to accelerated ageing tests at 20 kV. Figure 2 is a photograph taken in the lab of a bar whose junction was artificially degraded.

Figure 2 – Corona effect at a degraded junction subjected to 20 kV in the laboratory

In the laboratory, breakdowns occurred inside the slot near the slot exit. The same kind of defect was observed earlier in generators with fairly marked signs of the corona effect. At the time, however, we were unable to associate the defects with deterioration of the junction. The hypothesis put forward to explain this phenomenon is that when the junction has completely deteriorated, the overall surface current from PD activity exceeds the ohmic resistance of the semiconductive paint. The current is near-uniformly distributed around the bar between the paint-paint junction and the iron substrate, and the current density is too weak to burn the semiconductive coating. Ground contact in the slot, however, is much less uniform due to the rough surfaces and inevitable gaps between the bar and the sides of the slot. Furthermore, since the coating has a much higher resistance at very high frequencies than at 60 Hz, the PD current would tend to drain to the iron as soon as it enters the slot. Discharge currents will thus drain to ground at just a few spots. The local current density can therefore be very high and can raise the temperature above the acceptable limit for the coating, thus causing it to burn. This will cause the corona to appear in the slot and may lead to breakdown of the ground-wall insulation.

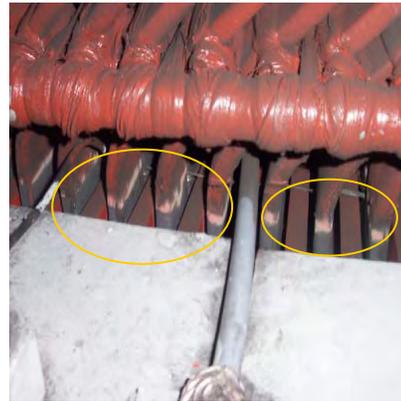
Figure 3 – Priority 1 signs of the corona effect

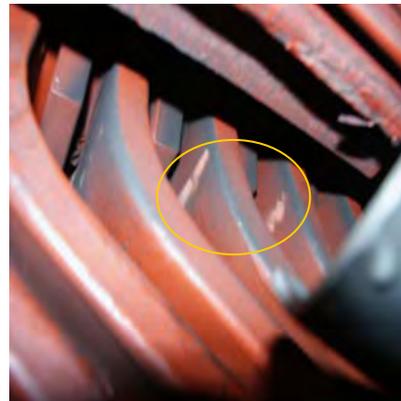
Figure 4 – Priority 2 signs of the corona effect

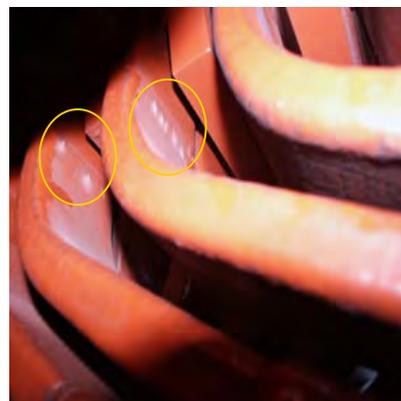
Figure 5 – Priority 3 signs of the corona effect

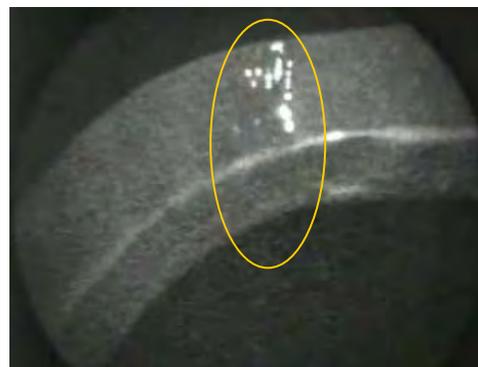
To better understand the problem of corona effects and the poor initial performance of coatings, IREQ conducted tests with an ultraviolet (UV) camera on spare bars supplied some 30 years ago (Figures 6 and 7). During lab tests on 31 stator bars from three manufacturers and with four kinds of semiconductive and stress-grading coatings, corona inception voltages (CIVs) as low as 5.2 kV were recorded at the stress-grading junction. Such values are clearly unacceptable since bars on the phase side of the stator winding are permanently subjected to 7.9 kV on most Hydro-Québec generators. Some bars, however, had excellent results (see Table 1).

Figure 6 – UV camera view of the corona discharge at the junction – Case 1

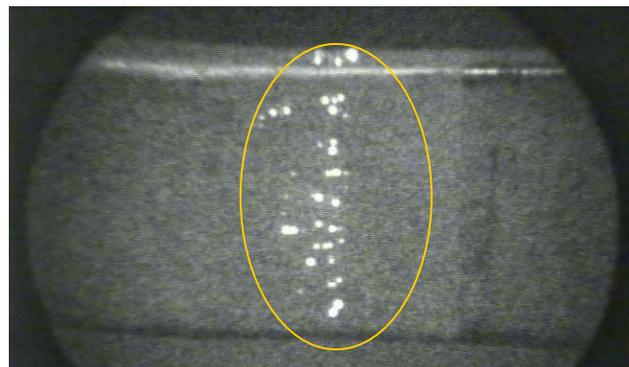
Figure 7 – UV camera view of the corona discharge at the junction – Case 2

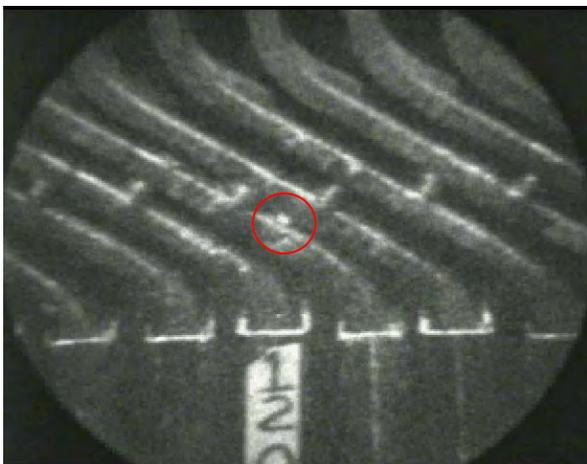
Besides factory tests that ensure that the stress-grading coating itself is of high quality, other testing is carried out at the generating station after the unit has been assembled but just before applying finishing paint. This final testing ensures that defects did not slip in during assembly (scratches, chipped paint, inadequate spacing, mispositioned RTD cable, etc.). During generating station testing, each stator phase is energized while the other two phases are grounded. The test voltage is 12 kV AC at ambient temperature. Spots with visible PDs must be repaired by sanding, cleaning or applying stress-grading paint.

Figure 9 – Sign of the corona effect in the generating station
