06 November 2001

Performance of DayCor II

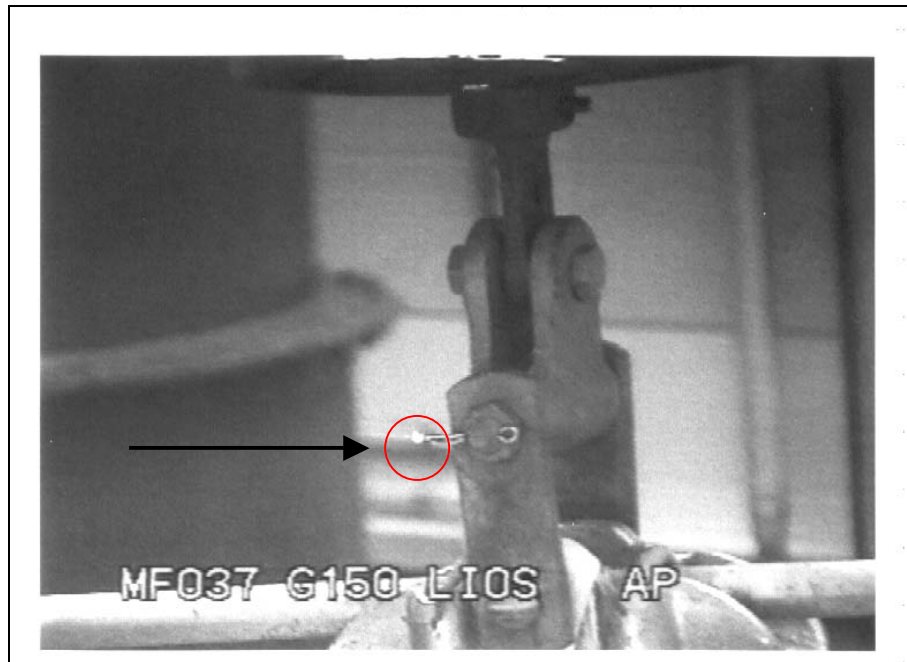
During a series of tests with porcelain insulators of cap-and-pin type, discharges from the tip of a split-pin were observed with the camera (see Figure 1). The discharge level was simultaneously measured with an ordinary PD-measuring circuit. The minimum discharge level, visible indoors with DayCor II, was about 5 – 8 pC at 6 m distance.

Figure 1. Discharges from the tip of a split pin.

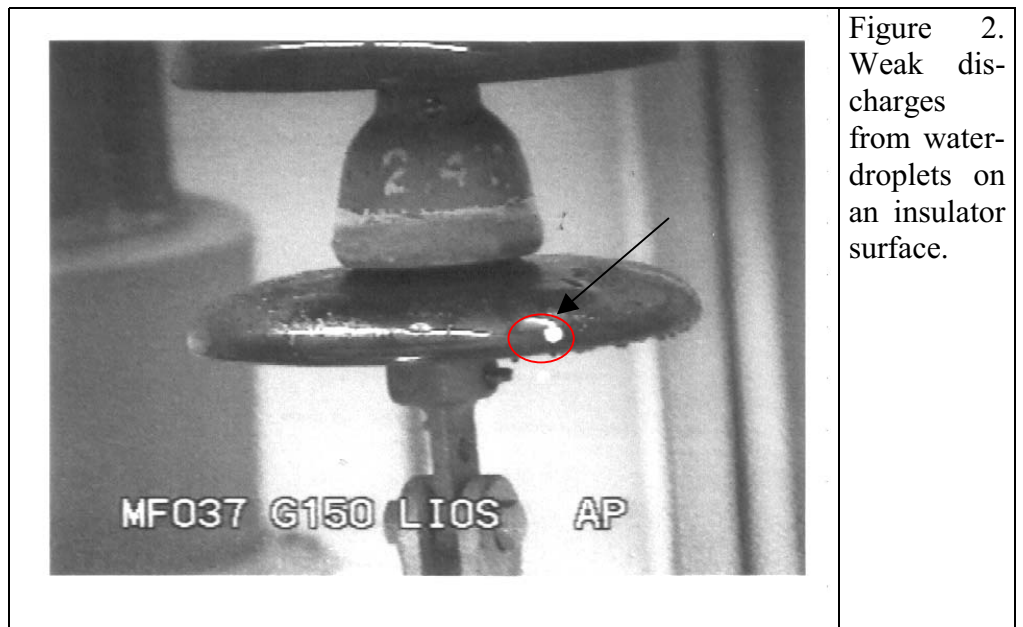
Weak discharges from droplets of water on an insulator surface can also be seen with the camera. An example of this phenomenon is given in Figure 2.

Figure 2. Weak discharges from water-droplets on an insulator surface.

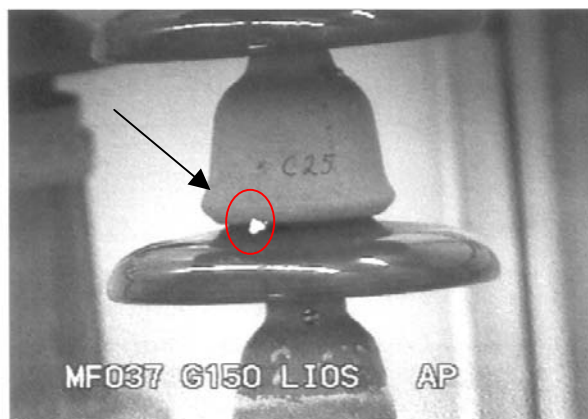
Figure 3, below, gives another example of discharges from an area with high electric field. Discharges of this type may be an indirect indication of short-circuited insulator units in the string.

Figure 3. Discharges from the slot between the metal cap and the porcelain. This unit is sound, but this may be an indirect indication of one or more damaged insulator units in the string.

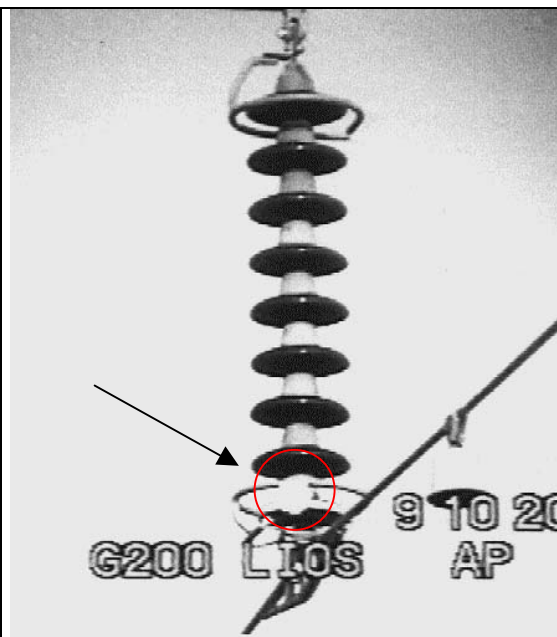
A number of porcelain insulator strings for 130 - 155 kV system voltage have been studied both in the laboratory and outdoors. An example of a weak indication of a damaged insulator can be seen in Figure 4.

Figure 4. UV-photo from a 155 kV line. A weak UV indication from insulator no 9.

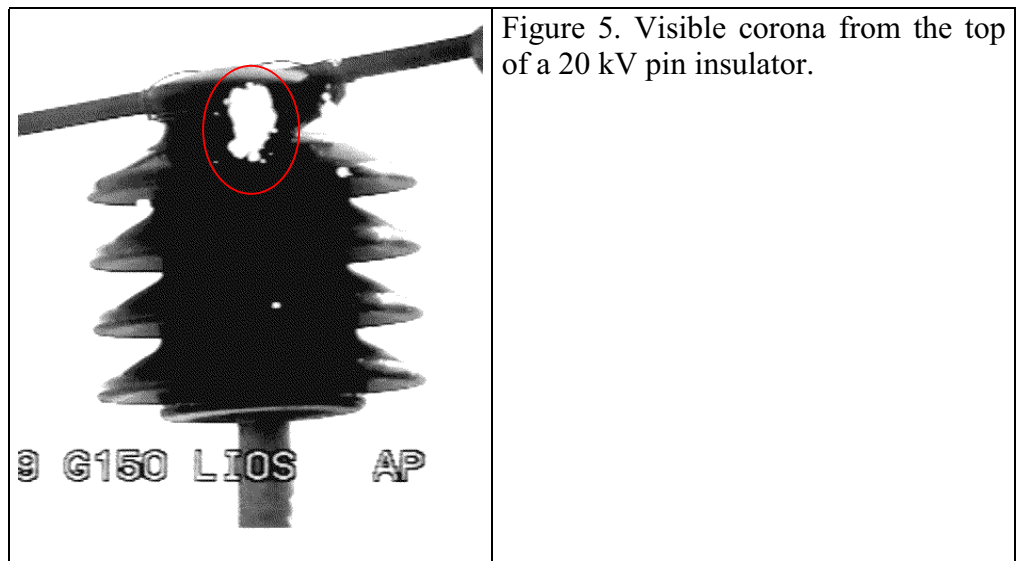
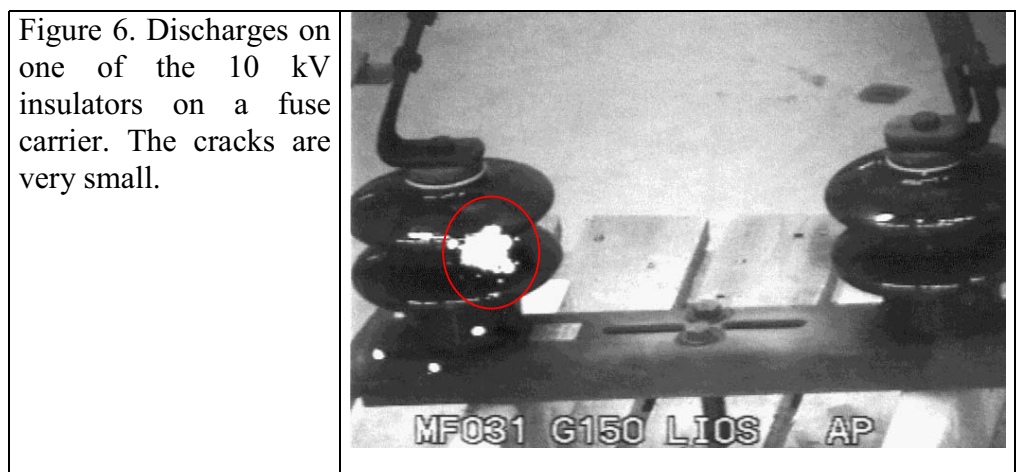
The result for 10 & 20 kV system voltage is promising. Insulators with small cracks between high-voltage end and ground can be detected with the UV-camera (Figure 5 and 6.).
